**International Road Tunnel Fire Detection  
Research Project – Phase II**

**Task 7: Full-Scale Ventilated Fire Tests in a Laboratory  
Tunnel for Study of Tunnel Fire Detection Technologies**

**Z. G. Liu, G. Crampton, A. Kashef, G. Lougheed, E. Gibbs  
and S. Muradori**  
National Research Council of Canada

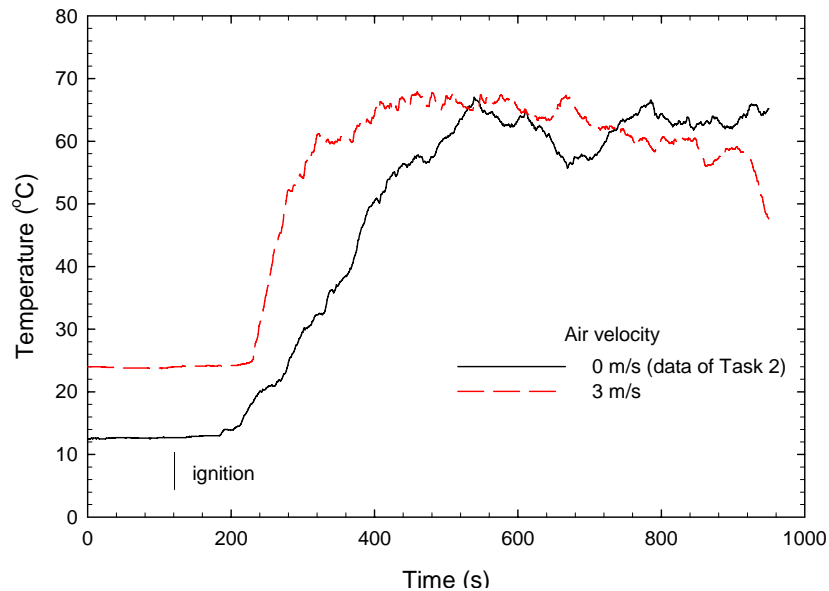
**Figure 7.54. Ceiling temperature measured at Thermocouple #33 at center of the tunnel with a simulated passenger compartment fire**

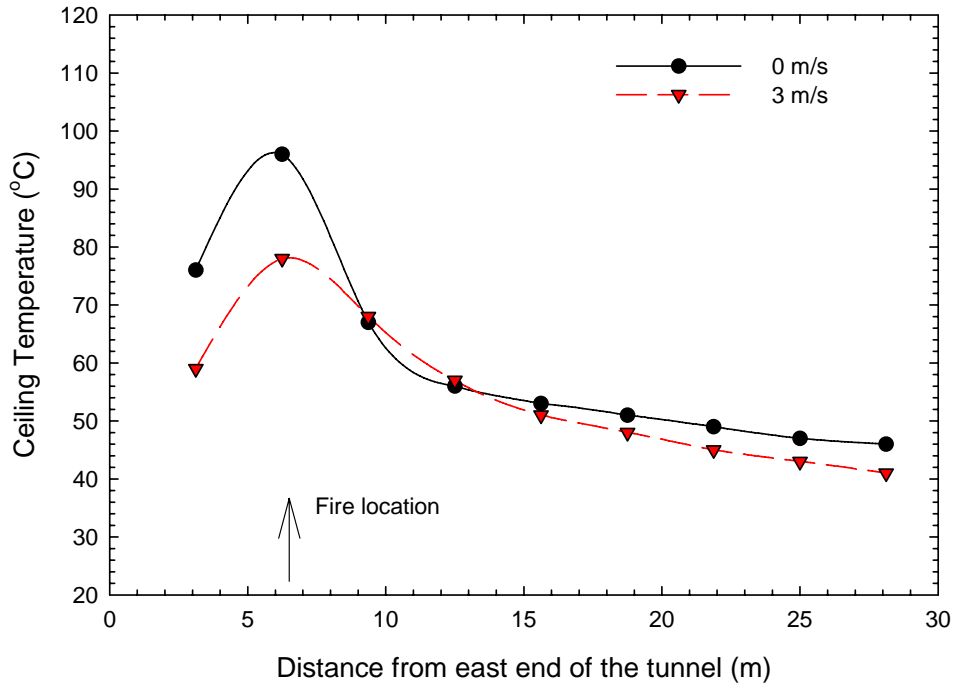
**Figure 7.55. Variation of maximum ceiling temperature at the center of the tunnel with a simulated passenger compartment fire**

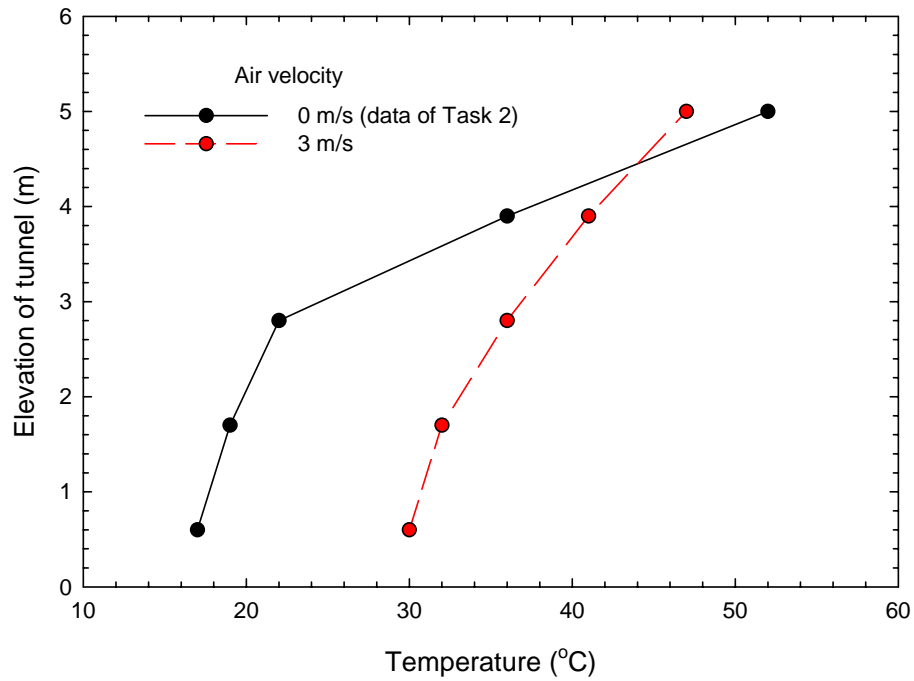
**Figure 7.56. Variation of maximum temperatures with elevation for a simulated passenger compartment fire**

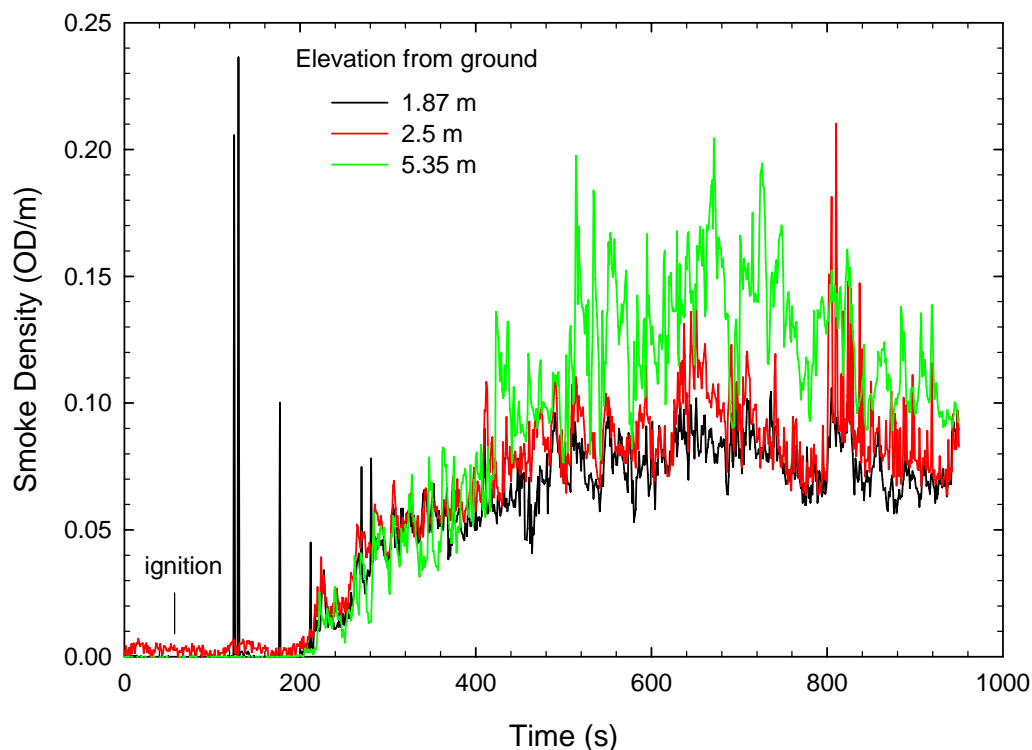
**Figure 7.57. Variations of smoke optical density at three elevations produced by a simulated passenger compartment fire**

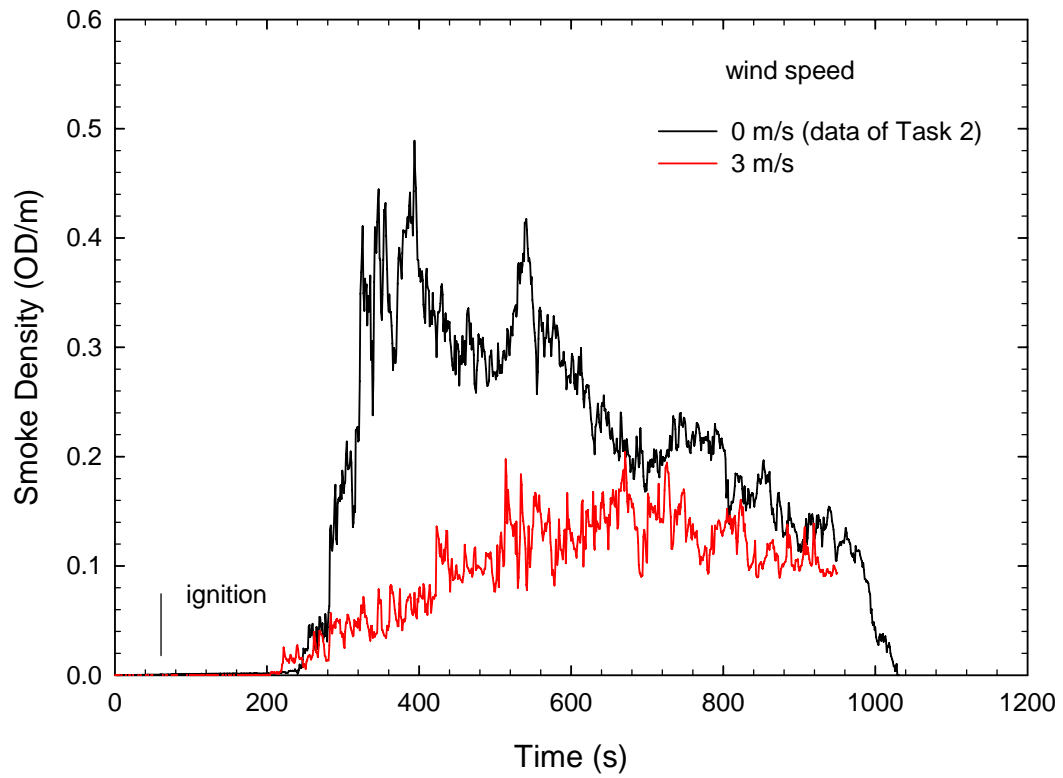
**Figure 7.58. Smoke optical density near the tunnel ceiling measured at the middle of the tunnel produced by a simulated passenger compartment**

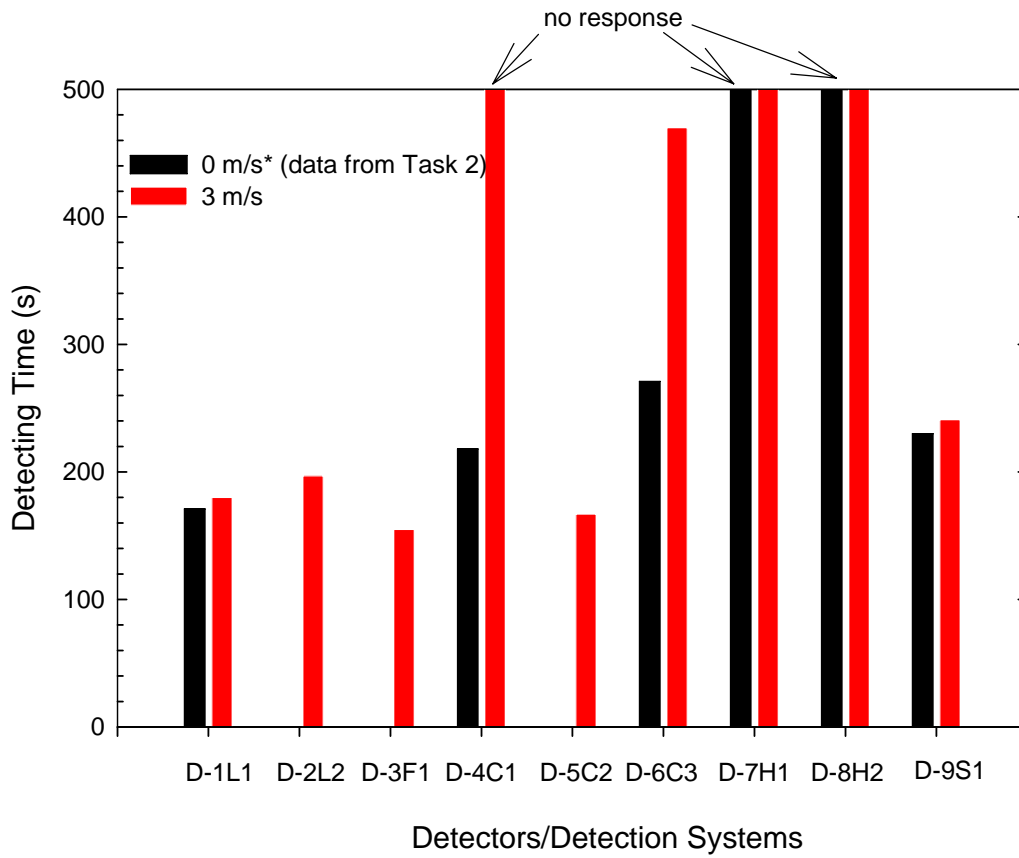
**Figure 7.59. Response times of fire detection systems to the simulated passenger compartment fire**
